# LOUISIANA DEPARTMENT OF WILDLIFE & FISHERIES

WATERBODY MANAGEMENT PLAN SERIES

# **TURKEY CREEK LAKE**

LAKE HISTORY & MANAGEMENT ISSUES

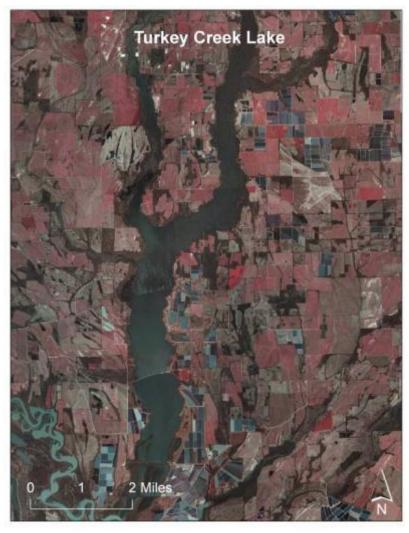
Figure 1. Aerial photo of Turkey Creek Lake, Louisiana.

$\overline{3,080}$  acres, shown below in Figure 1.

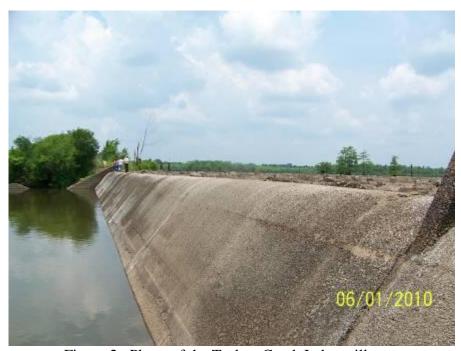
#### Spillway (Figure 2)

Low crest width = 250 ft.; elevation = 44.0 ft. NGVD

Figure 2. Photo of the Turkey Creek Lake spillway.

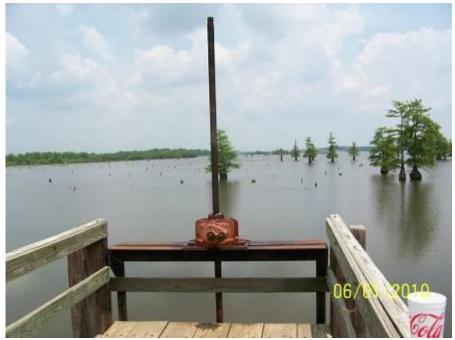
Structure -48 in. gated culvert with manual opening by vertical lift stem and wheel Number of culverts -1

Condition – constructed in 1963, functional but severely rusted

Drawdown Capability – approx. 9 ft. total, rate unknown

Figure 3. Water control structure located at the dam on the southern end of Turkey Creek Lake, LA.

A photo of the drawdown structure is shown in Figure 3 and the location of spillway and drawdown structure is shown in Figure 4.

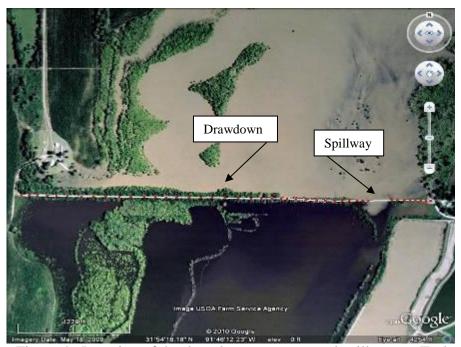
Figure 4. Location of the drawdown structure and spillway on Turkey Creek Lake, LA.
